ARBORICULTURAL ASSESSMENT & IMPACT REPORT

‘Mountgorry Large-Scale Residential Development’

Project No.	Project name	Date	Revision
TMON003	Mountgorry	25/09/23	D

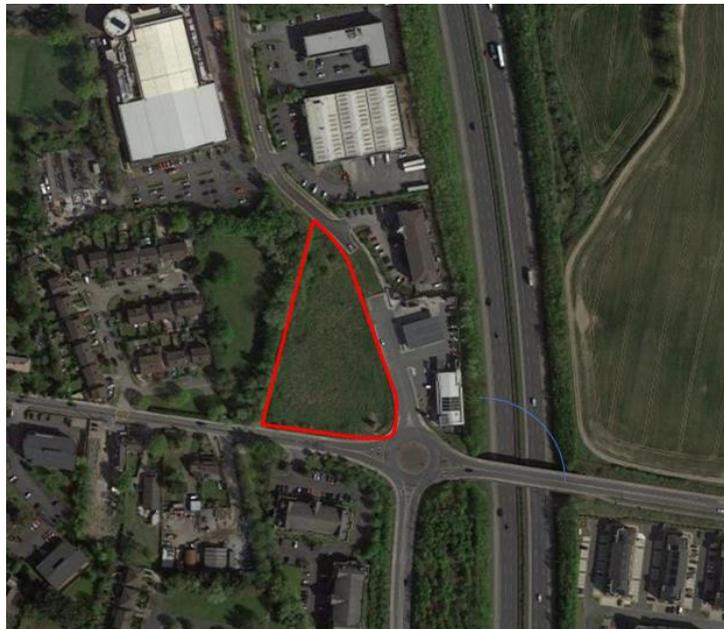
Image 1. Main development site. Note presence of trees within neighbouring site to west.

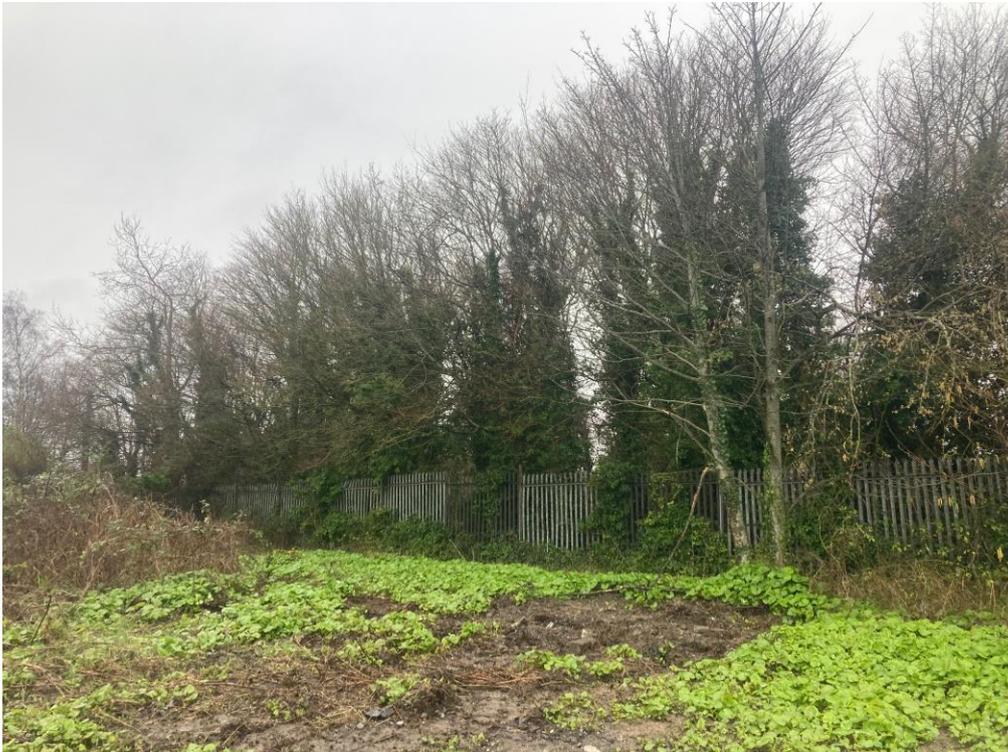
Image 2. Tree #569 (arrowed) with trees within neighbouring site behind boundary fence. Note restriction on canopy growth of tree #569 from trees within neighbouring site.
