Mountgorry LRD Swords

Stage 1 Road Safety Audit

Bartra Propco 23 Limited

September 2024

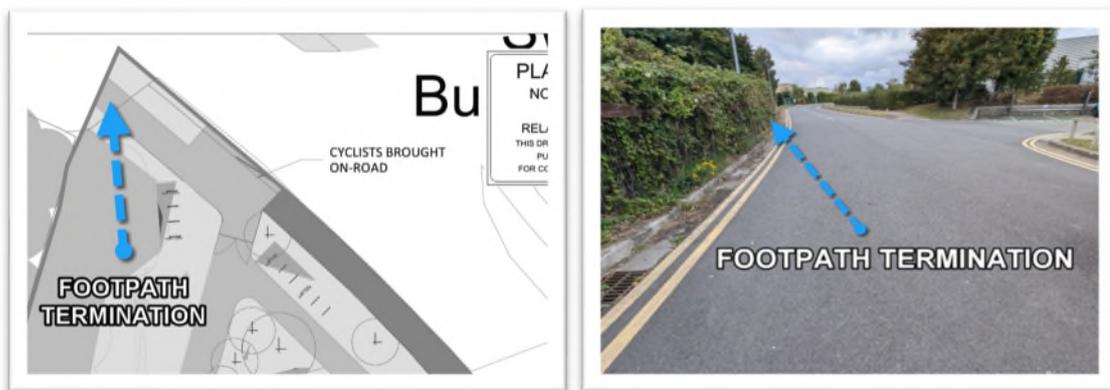
Figure 2.1 – Footpath Terminates Abruptly Opposite Business Access

Location: Northern Site Boundary

The footpath terminates abruptly at the northern development boundary, which may lead to walkers stepping into the adjacent road carriageway unexpectedly. This could increase the risk of conflicts between vehicles and vulnerable road users.

A suitable crossing connection should be provided to the existing (continuous) footpath on the opposite side of the road.

2.1	Yes	No	This footpath is allowed for as a future connection, nevertheless, to address this issue to the fullest extent possible we will provide a revised drop kerb at the footpath termination in a safer location, away from the conflict zone with the access junction on the opposite side of the road in this area.	Yes

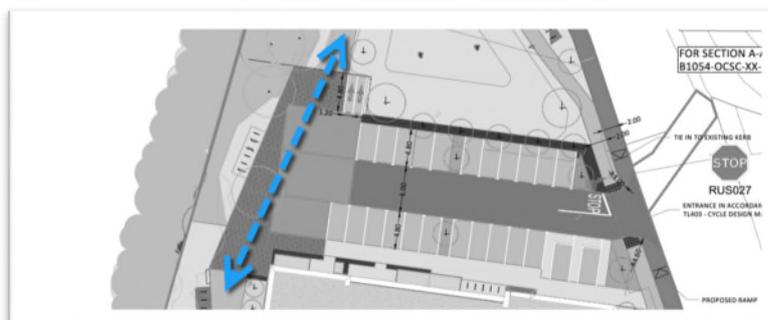
Figure 2.2 – Key Pedestrian Walking Desire Line Through Vehicle Turning Area

Location: Across Western Edge of Parking & Turning Area

The footpath demarcation appears to terminate either side of an area which will be used by vehicles to reverse and execute turning manoeuvres. This could lead to reversing type conflicts between vehicles and vulnerable road users here.

A continuous (segregated) footpath should be provided through this area.

2.2	Yes	Yes	This area is intended to perform as a shared space and is expected to be used infrequently for smaller servicing vehicles only given the nature of use. We will investigate measures to delineate the footpath through this area for mobility impaired road users during the subsequent detailed design stage.	Design comment noted and accepted.

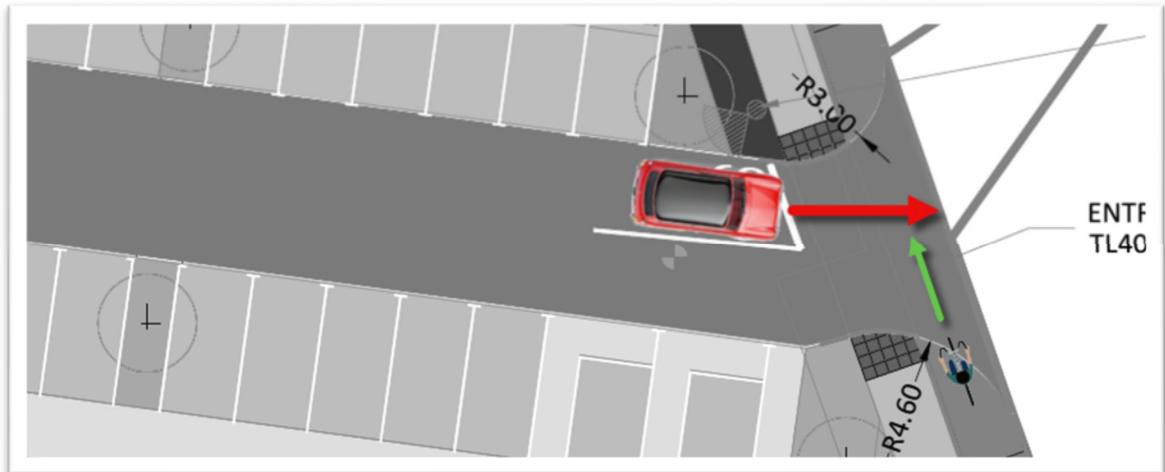
Figure 2.3 – High Cycling Speeds on Downhill Approach to Development Access

Location: Vehicle Access to Public Road

The downhill approach from the roundabout to the vehicle access is likely to lead to higher cycling speeds. Cyclists (including E-Bikes & E-Scooters) are less likely to stop at the access, which could increase the risk of conflict with an emerging vehicle.

The risk of conflict should be managed by affording advantage to walkers and cyclists over vehicles at the development access. This should be achieved by continuing the footpath and cycle track (unbroken) across the access, with drivers being directed to give way to walkers and cyclists before 'crossing over' the unbroken footpath and cycle track.

2.3	Yes	Yes	The layout has been amended in accordance with the cycle design manual detail TL403.	Design comment noted and accepted.
